MOODY'S of Dayton, Inc. DBA  
**G.M. BAKER & SON**

5 August 2026

Subject: Wellston Creek Intake Pump

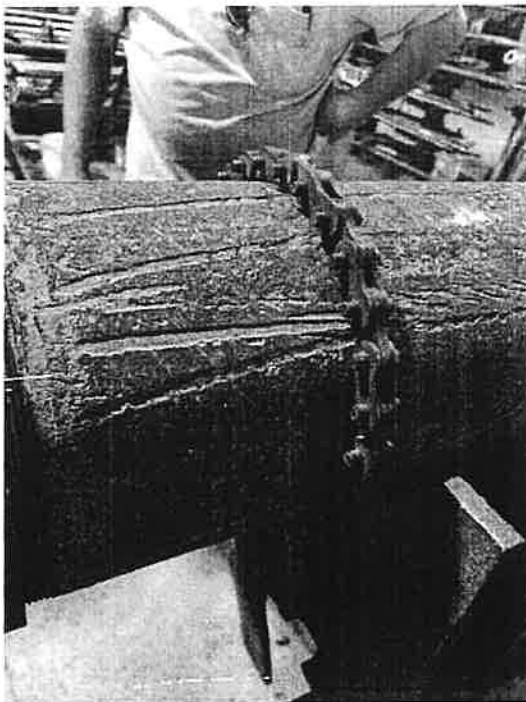
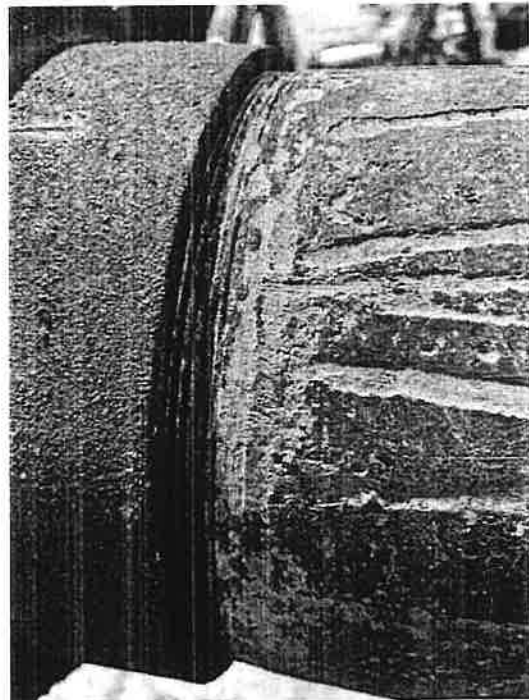
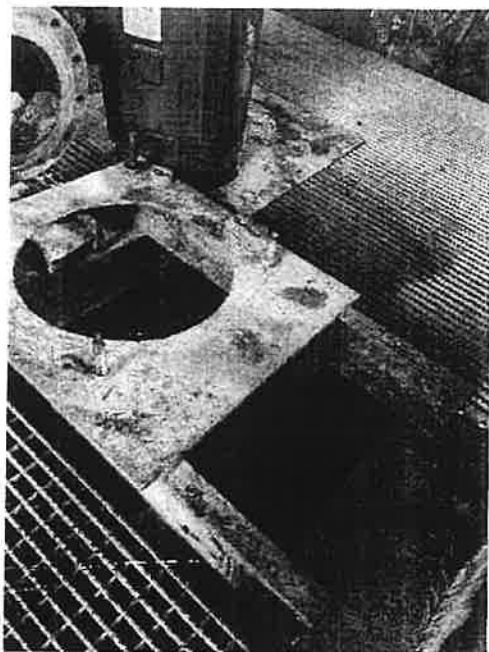
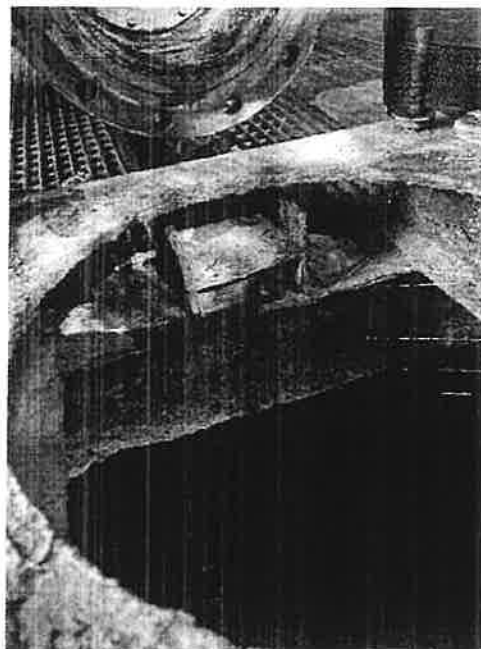
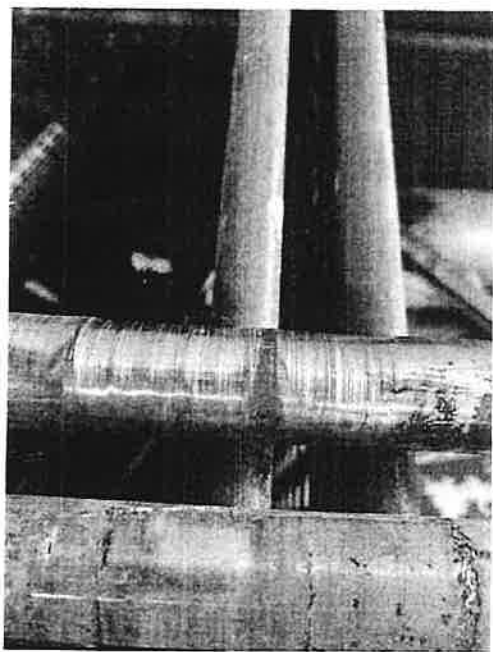
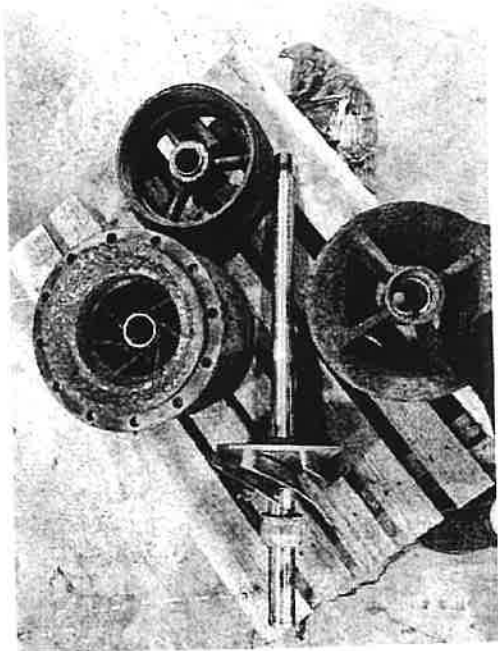
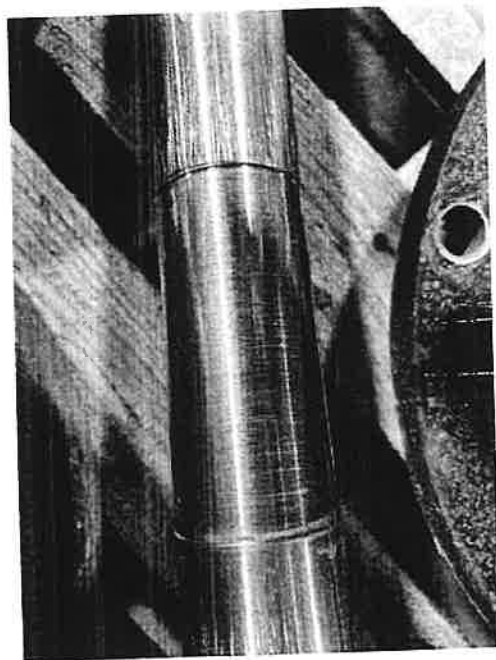
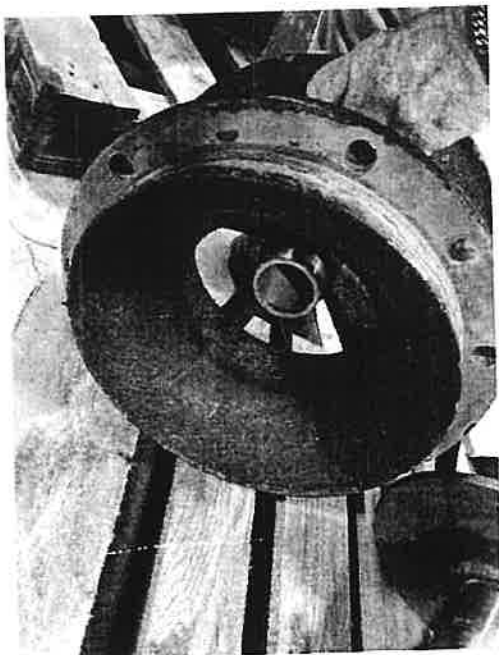
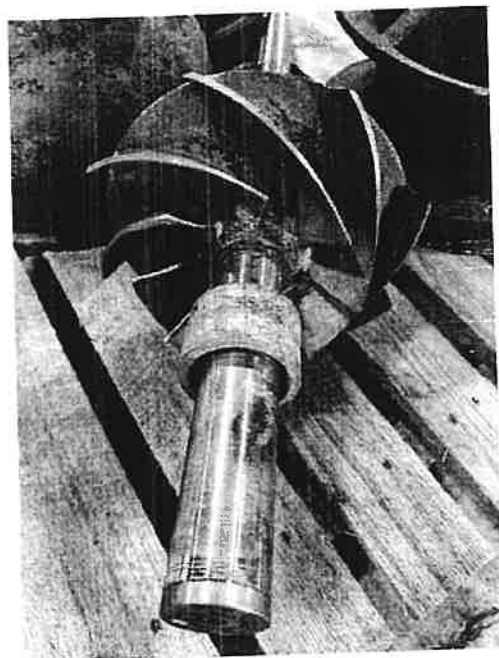
We have completed inspection of the subject pump. The pump center bushings indicate @  $\approx .150$ " which is very bad. The bowl shaft is required. This is not surprising considering the turbidity of the creek water. A new 10" x 10' column pipe is required. The existing pipe has excessive wash out. The top shaft was heavily worn and requires replacement as thought in the preinspection proposal. The intermediate shaft is 10' and not 5' as thought in the initial proposal.

The major support beams were inspected and found to be severely deteriorated, with portions completely rotted through. We are sending Brian Miller, our fabricator, to inspect the foundation beam system and determine whether a temporary repair can be completed to extend the service life of the existing foundation for approximately two years. The foundation is critical to supporting the weight and alignment of the pump. If the support system is not improved, movement and vibration may be transmitted throughout the pump assembly and contribute to continued mechanical wear.

| 1 | Ea | Mob/demob men and equipment, remove, pump assy, deliver to shop, disassemble, inspect. .... | \$ 2,000.00 |
| 1 | LS | Repair Pump with center bushings and new bowl shaft ..... | \$ 3,200.00 |
| 1 | Ea | Repair discharge head and packing box. .... | \$ 2,000.00 |
| 1 | Ea | 1 1/2" x 64" top shaft ..... | \$ 600.00 |
| 1 | Ea | 1 1/2' x 10' line-shaft ..... | \$ 600.00 |
| 1 | Ea | 10" x 9'-11 1/4" column pipe ..... | \$ 1,240.00 |
